Pierre Auger Observatory

Surface Detector Electronics Upgrade

UUB Pre Prototype Production Report

UUB Model version: SDE-002-002-IE00

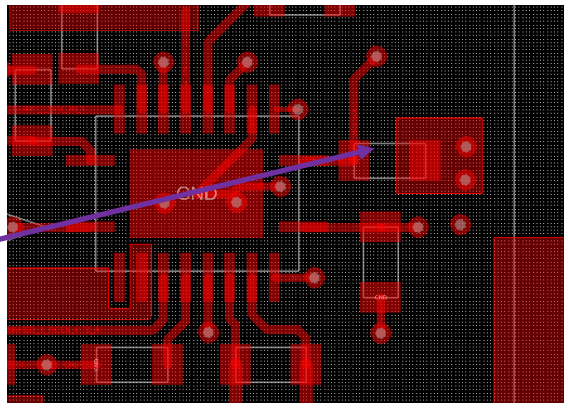
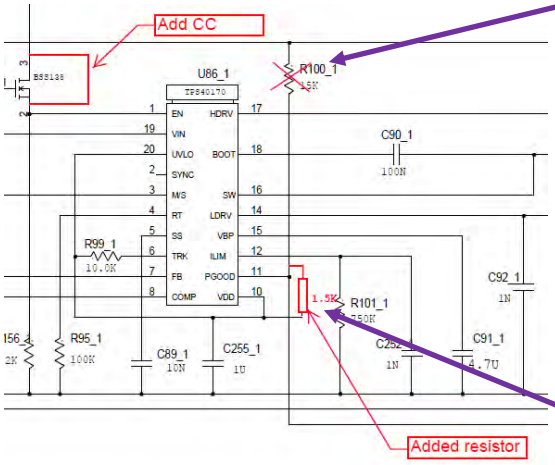
Figure 3: R100 removed

Figure 4: Valid_Alim modification in schematic (page 11)

Figure 5: 1,5 k Ohms resistor, and 0603 package added.

The Valid_Alim is generated by 1 Volt DC/DC converter, from its “power good” pin.
R100_1 is removed.
A 1,5 K Ohms 1 % resistor, 0603 package must be added between VDD (U86_1 pin 10) and PGOOD (U86_1 pin 11).

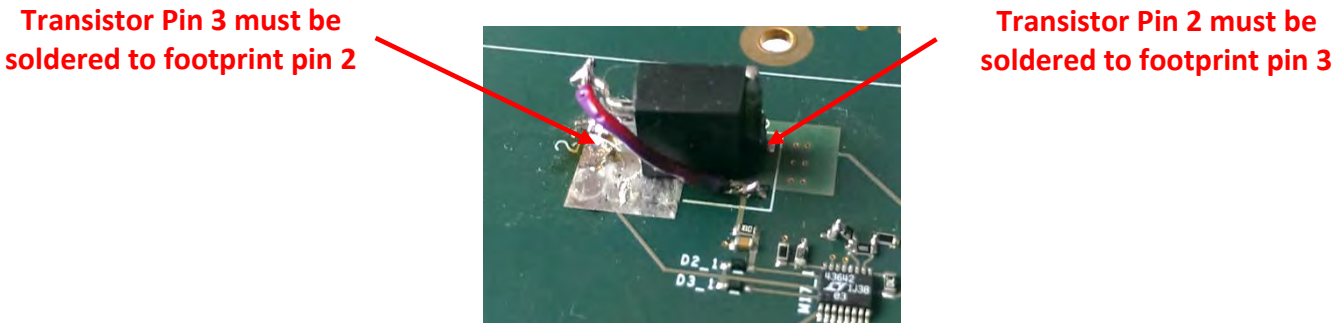
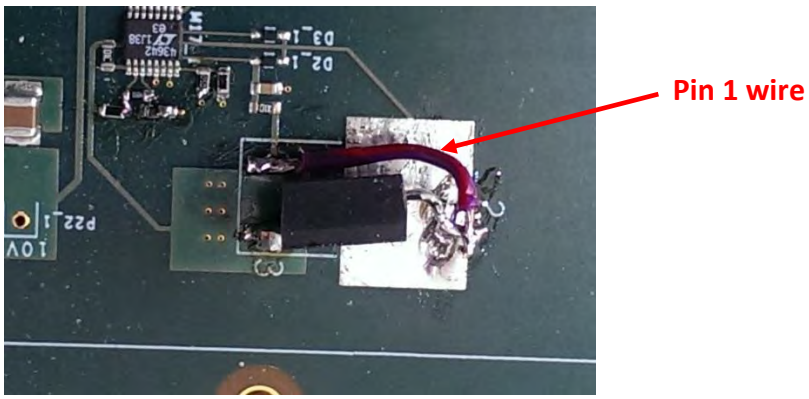
Wrong footprint for Q4_1 transistor. Pins 2 & 3 must be swapped.

Figure 6: Pin 2 &3 Swap connection.

Figure 7: Pin 1 wire connection.

The connection between transistor pin 1 to the footprint must be made by a wire.

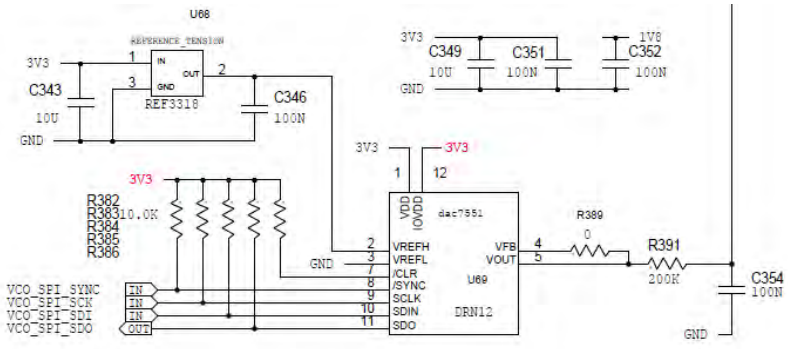
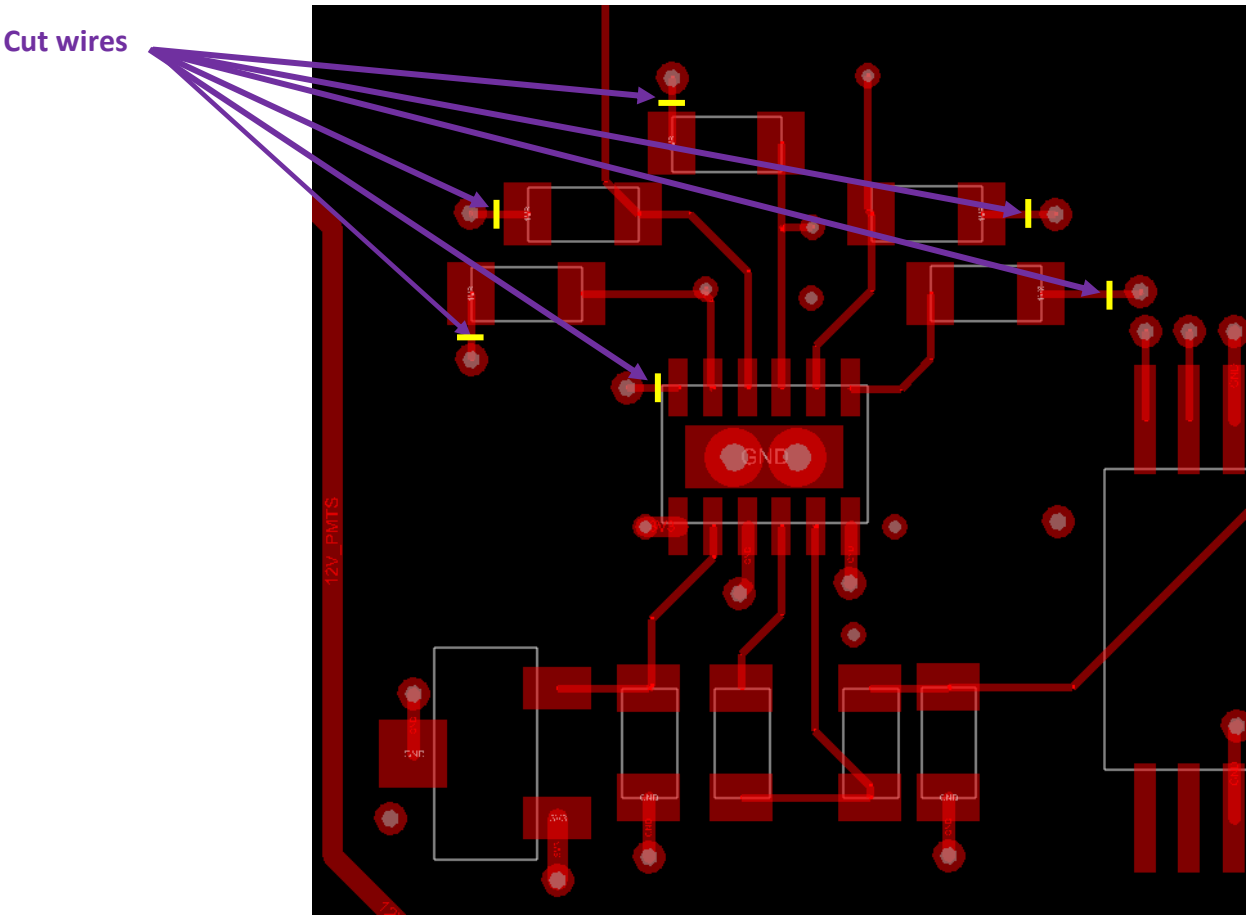
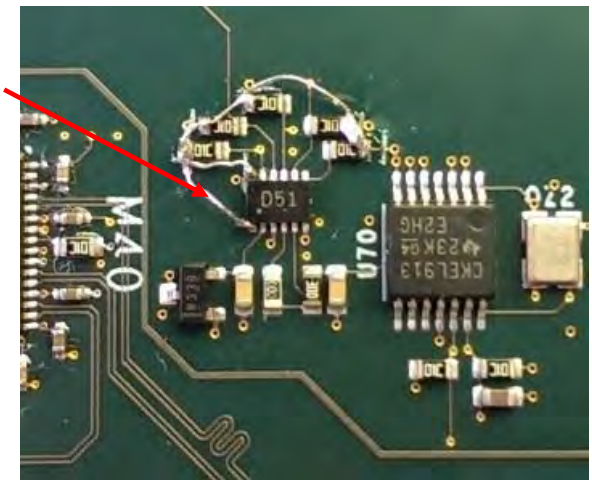
Figure 8: DAC7551 Power supply modifications (Schematic page 6).

Figure 9: Cut DAC7551 1,8 Volts Power supply wires.

Figure 10: DAC7551 Power supply modifications on UUB

DAC7551 IOVDD pin must be connected to 3,3 Volt (1,8 volt previously) power supply and the pull-up resistors R382, R383, R384, R385 & R386 too.

3,3 Volts power supply modifications. Add wire between U69 pin 12 and resistor R382, R383, R384, R385 & R386

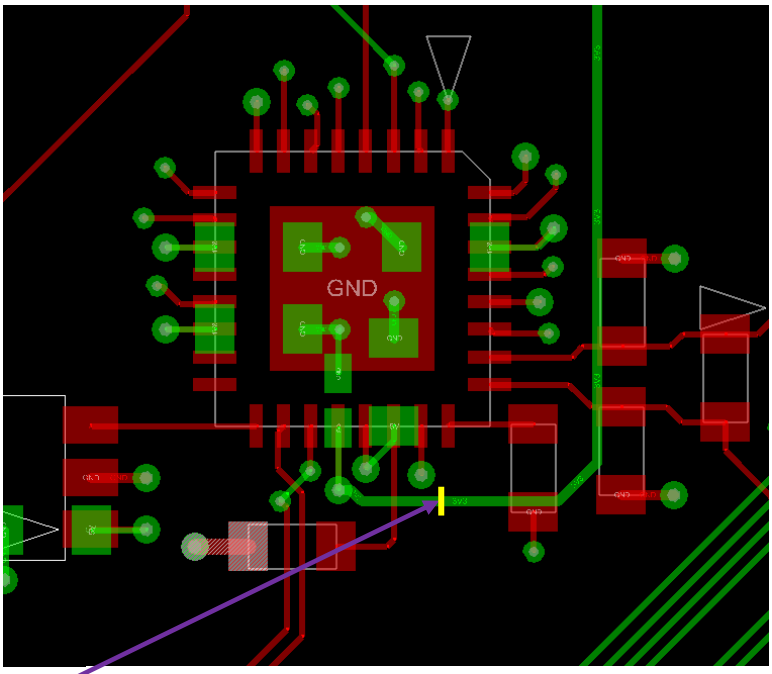
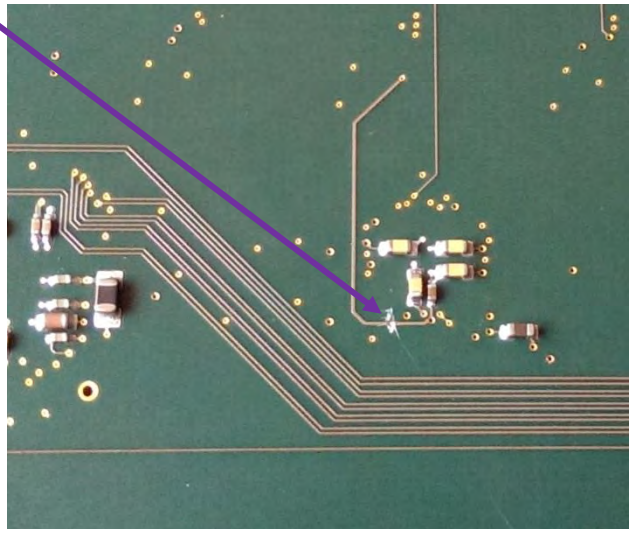
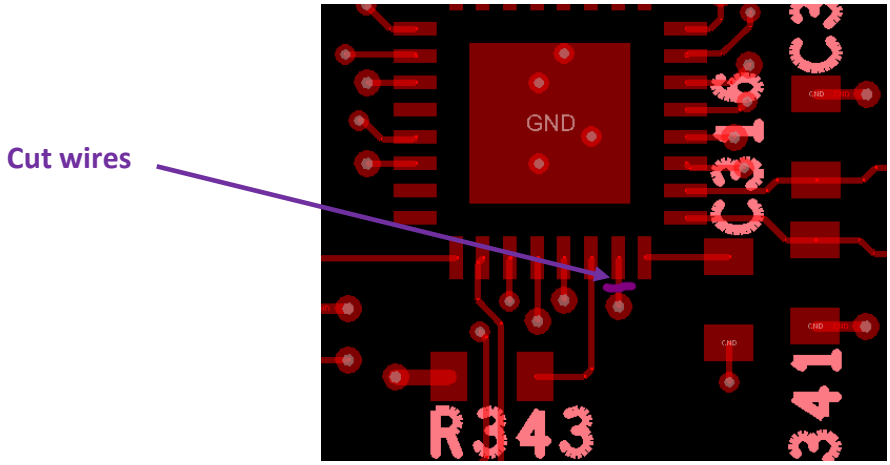
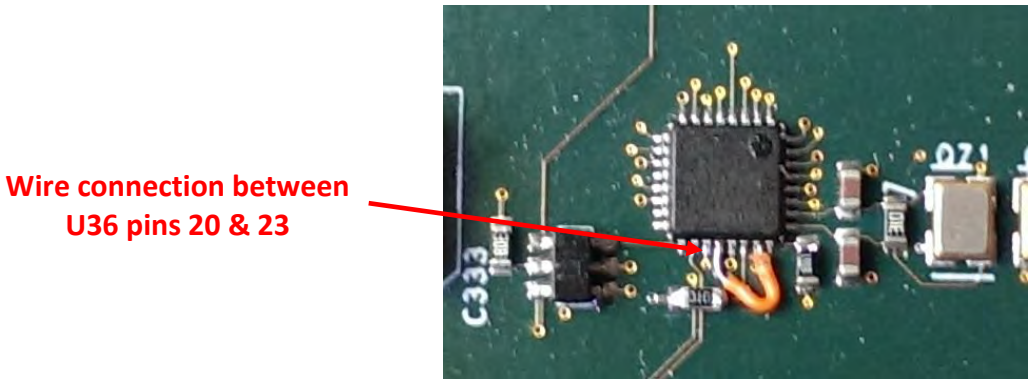
Figure 11: 3,3 Volts wire cut.

Figure 12: 3,3 Volts wire cut on bottom side.

Figure 13: 1,8 Volts wire cut.

Figure 14: U36, pins 20 & 23 wire connection.

U36 pin 20 must be disconnected from 3,3 Volts and connected to U36 pin 23.

U36 pin 23 must be disconnected from 1,8 Volts and connected to 3,3 Volts.

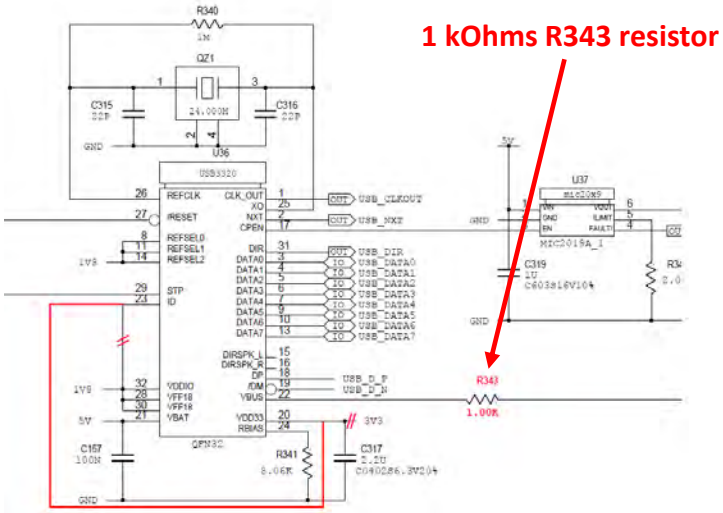
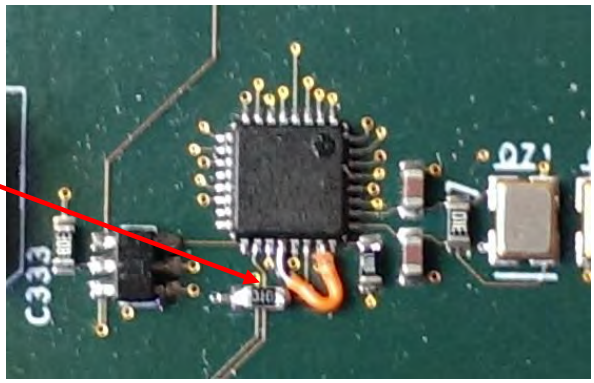
The VBUS R343 resistor value is bad in the Bill Of Material. It must be 1 kOhms instead 10 kOhms (NCR n° 2-43).

Figure 15: R343 resistor value changed to 1 kOhms (Schematic page 4).

Figure 16: 1 kOhms R343 resistor on board.

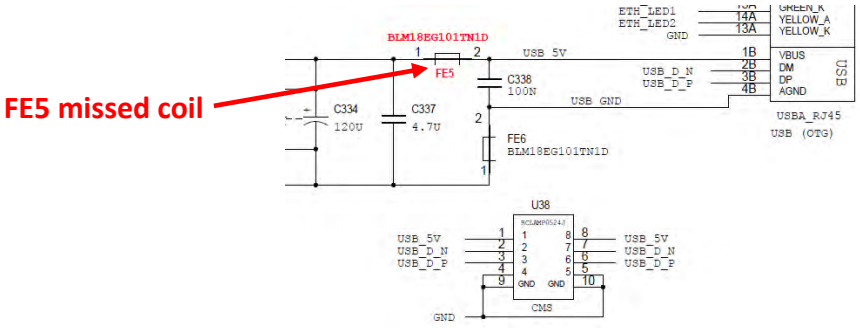
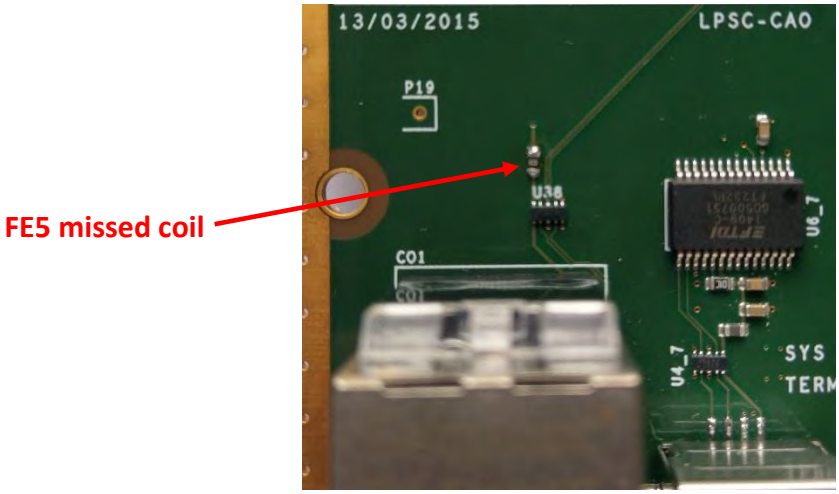
The FE5 coil has been forgotten in the BOM. A 0 Ohm resistor or a short-cut could be put (NCR n° 2-42).

Figure 17: Missed FE5 coil (Schematic page 4).

Figure 18: Missed FE5 on board.

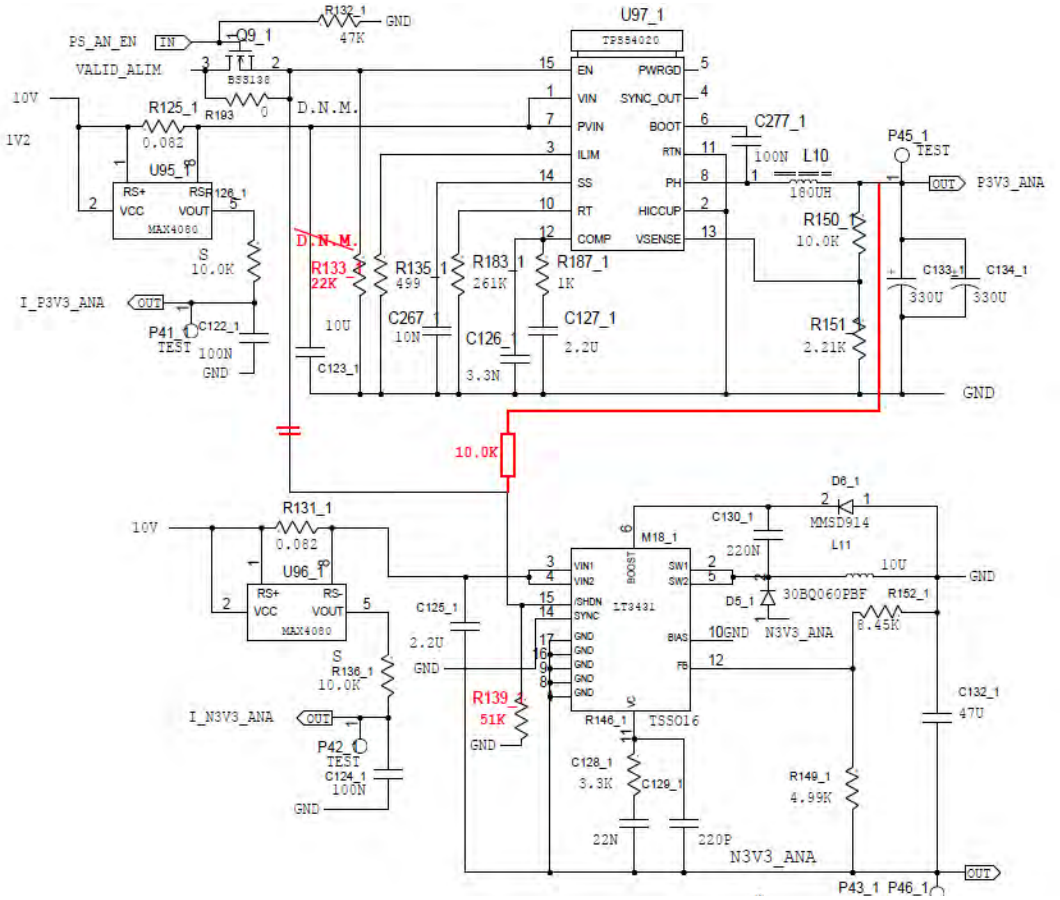
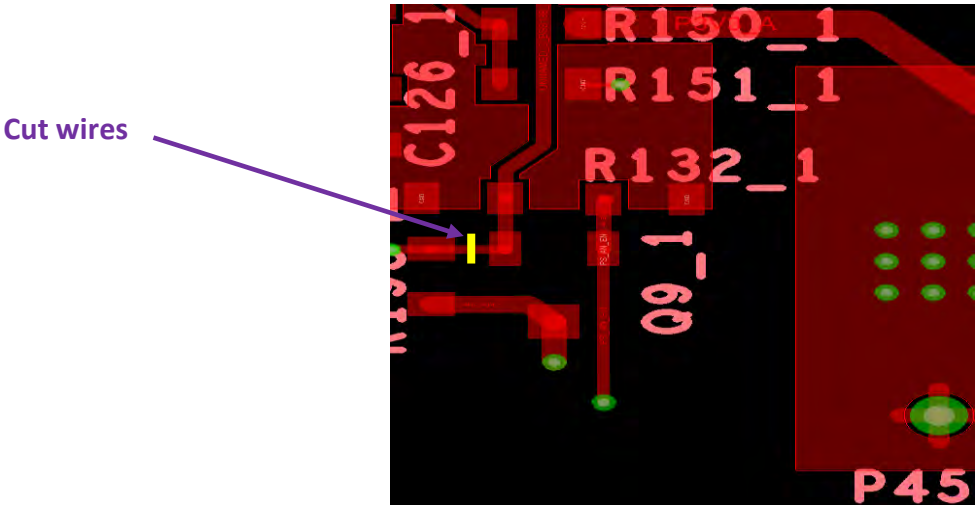
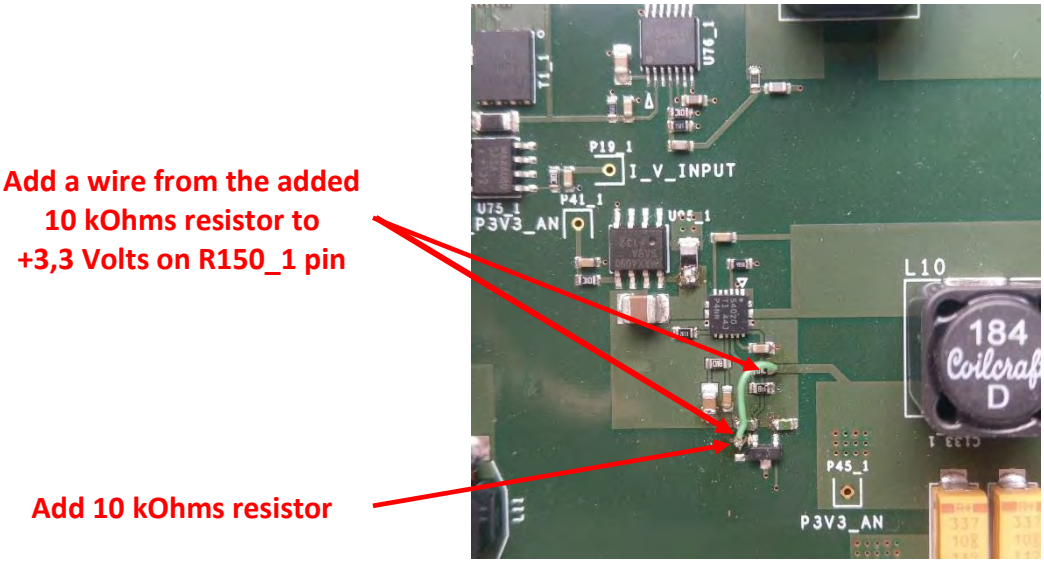
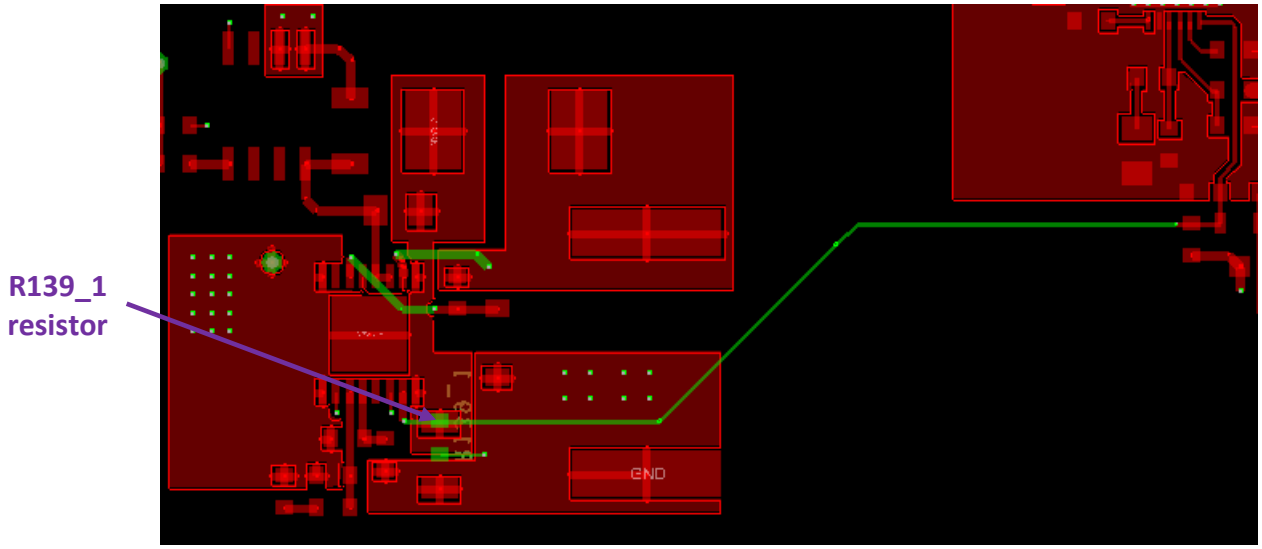
Figure 19: +/- 3,3 Volts Enable modification (Schematic page 10).

Figure 20: Wire cut.

Figure 21: Top side modifications.

Figure 22: BOTTOM side R139_1 resistor value modification.

For the SDE-002-002-IE00 UUB board only, the +/- 3,3 Volts Enable will be send from the Slow-Control micro-controller (3,3Volts) to U97_1 +3,3V DC/DC pin15 (EN) and U18_1 -3,3V DC/DC pin 15 (/SHDN). The +3,3V DC/DC output will enable the -3,3V DC/DC enable.

R139_1 resistor value must be changed from 22 kOhms to 71 kOhms.

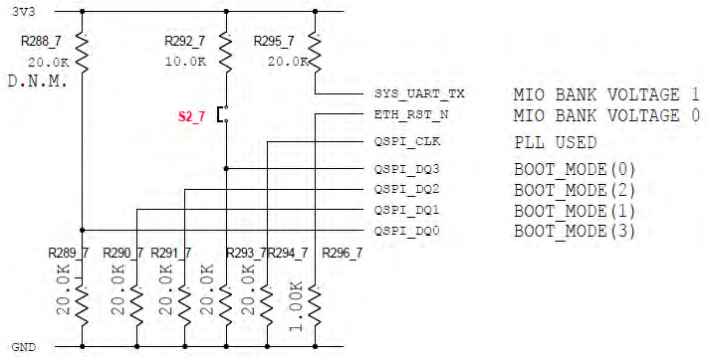
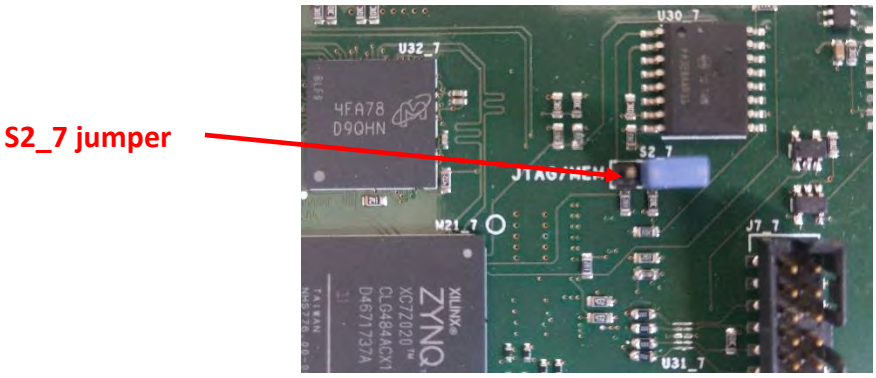
The boot configuration jumper (S2_7) has been forgotten in the Bill Of Material (NCR n° 2-1). It must be added.

Figure 23: FPGA boot configuration jumper (Schematic page 23).

Figure 24: FPGA boot configuration jumper added on board.

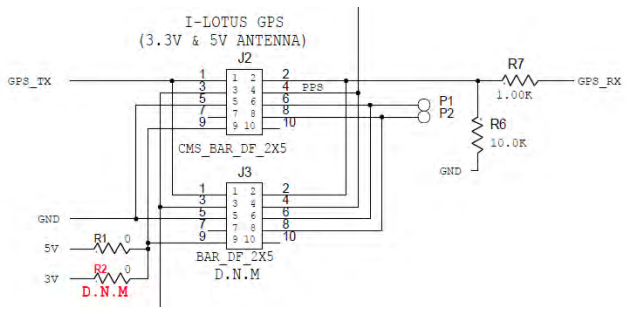
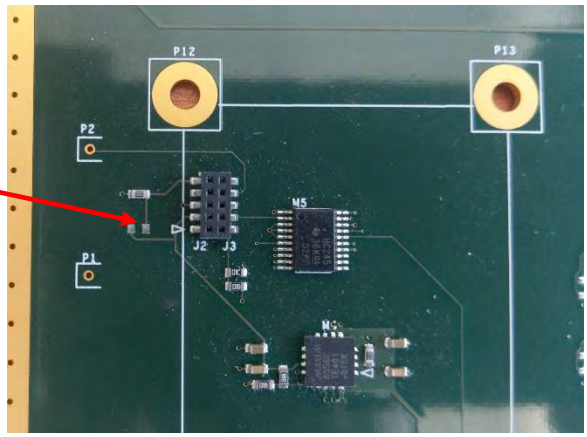
The GPS antenna could be powered by 2 types of voltages, 3 Volts or 5 Volts. On the board this choice is made by R1 and R2 0 Ohm resistors. Presently, the 2 resistors are soldered on board (NCR n° 2-2). R2 resistor must be removed.

Figure 25: GPS antenna configuration resistor (Schematic page 3).

Figure 26: GPS antenna voltage configuration on board.

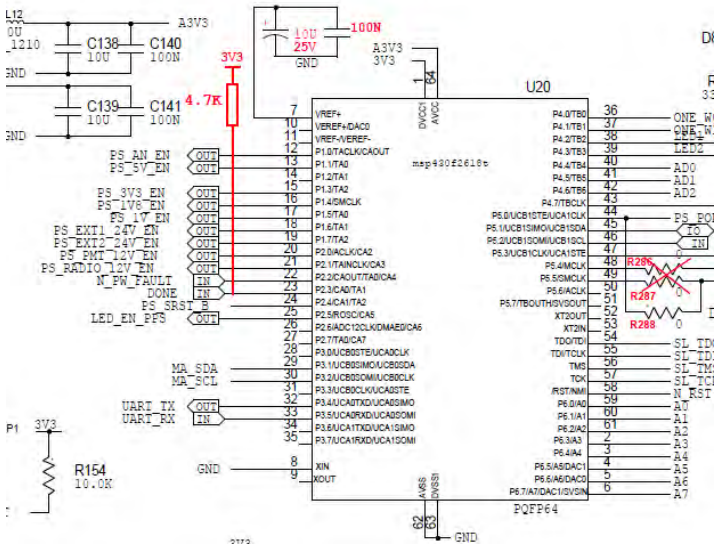
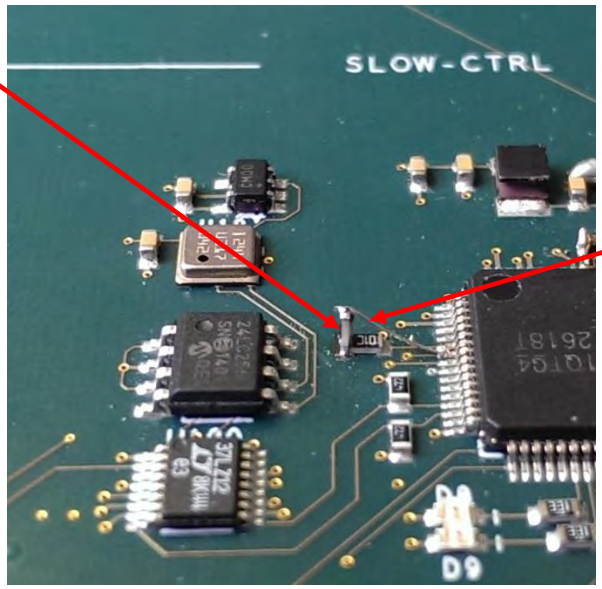
Figure 27: Slow-Control RESET configuration resistors (Schematic page 12).

DONE pull-up 4.7 kOhms resistor added

Wire connected to pin 23 on U20 and the added resistor

Figure 28: Slow-Control RESET & DONE configuration resistors on board.

4,7 kOhms 1% and 0603 package Pull-up resistor must be added between 3V3_SLOW_CTRL and U20 pin 23 (schematic page 12).

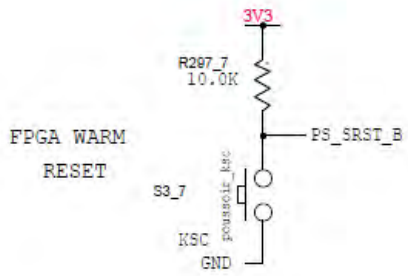
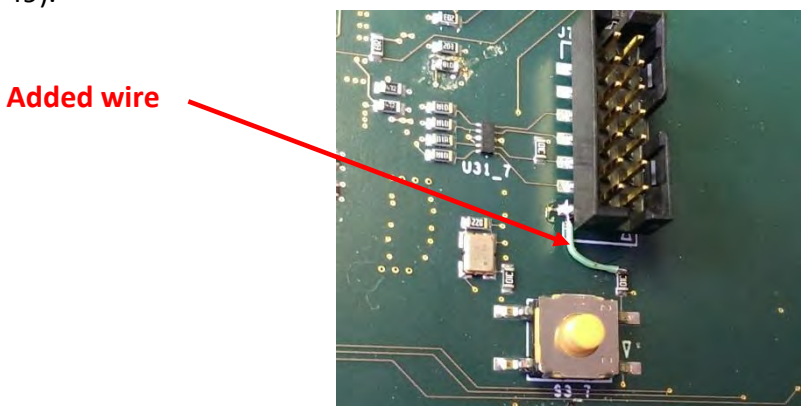
3,3 Volts is missing on Slow-Control Reset Pull-up R297_7 resistor. One pin is unconnected. It must be connected to 3,3 Volts power supply.

Figure 30: R297_7 pull_up resistor power supply on (Schematic page 12).

Figure 31: 3,3 Volts connection to 3,3 volts power suplly.

A wire must be connected from R297_7 resistor pin to the J7_7 connector pin 2 (3,3 Volts) (NCR n° 2-49).

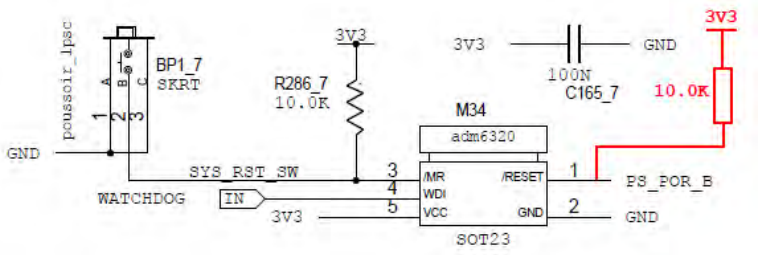
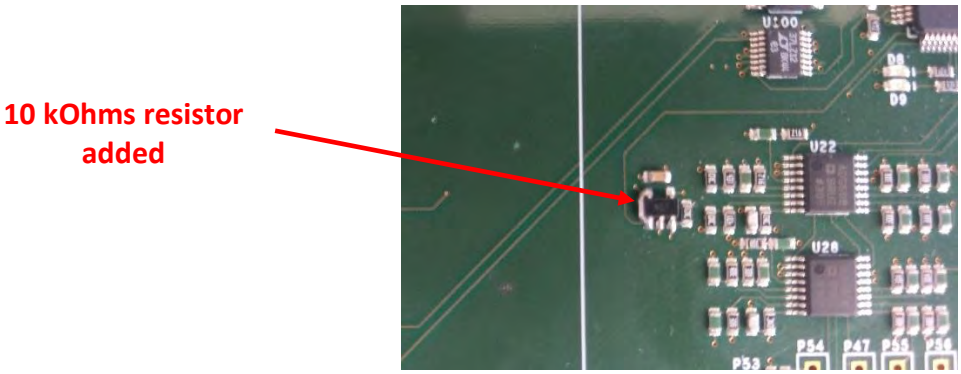
A pull-up resistor is missing in the schematic. A 10 kOhms resistor must be added between 1 and 5 pins for M34 components (NCR n° 2-22).

Figure 32: Pull-up resistor added on watchdog output (Schematic page 12).

Figure 33: Watchdog 10 kOhms resistor pull-up on board.

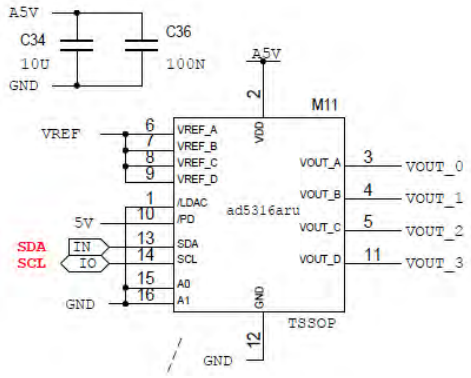
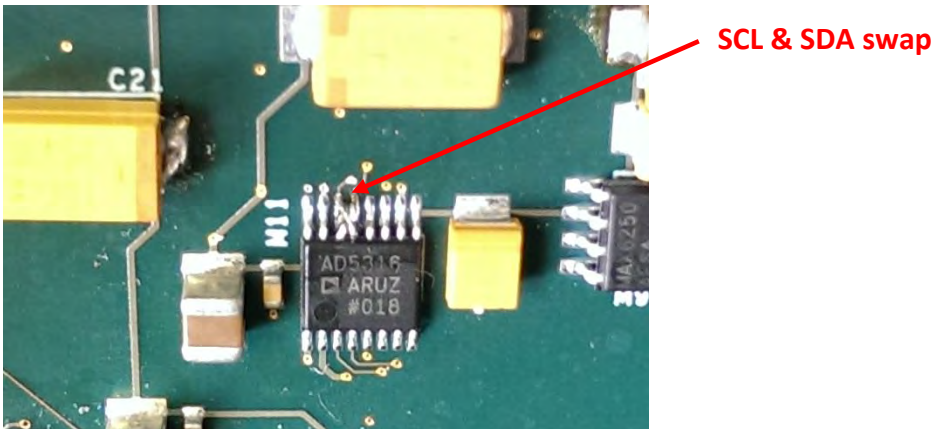
Error in the schematic, SCL & SDA pins must be swapped.

Figure 34: SCL & SDA wires must be swapped (Schematic page 7).

Figure 35: SCL & SDA wires must be swapped on board

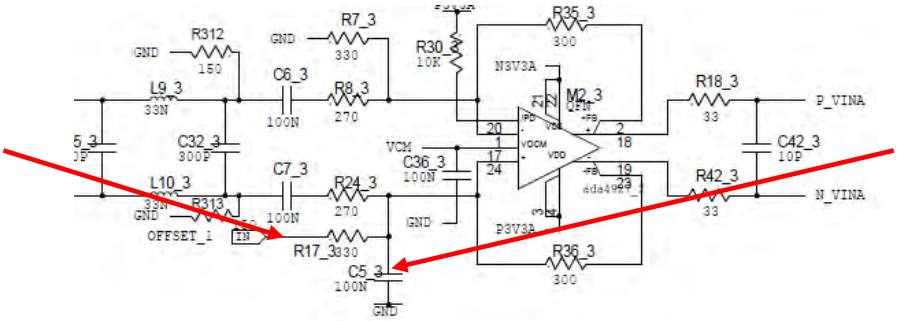
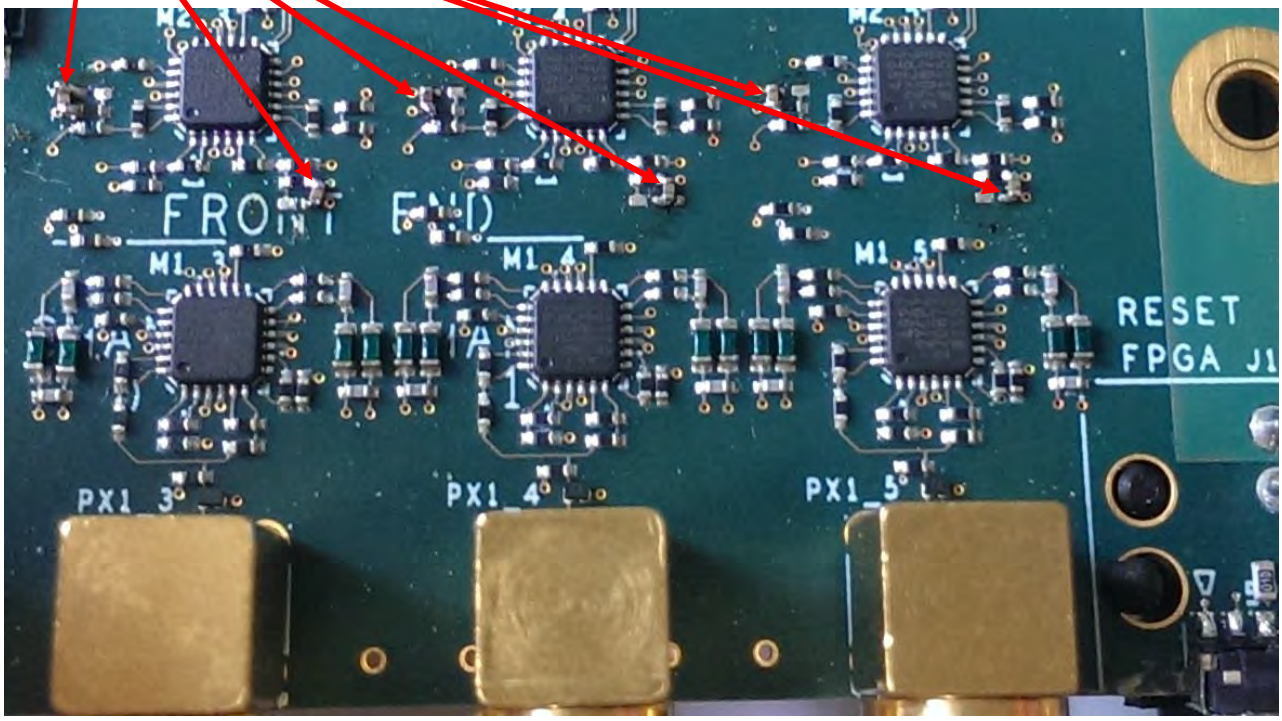
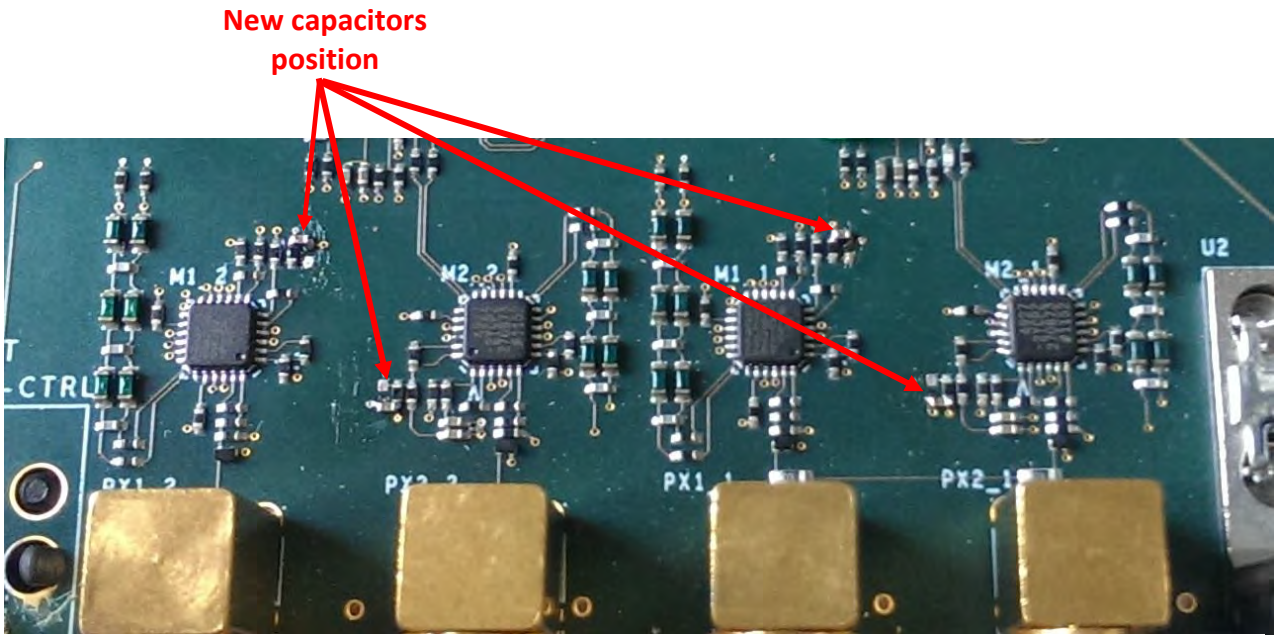
Offset 1 & 2 decoupling capacitors are in the wrong position in the schematic. These capacitors are: C5_1, C8_1, C5_2, C8_2, C5_3, C8_3, C5_4, C8_4, C5_5 & C8_5.

Figure 37: OFFSET_1 C5_3 decoupling capacitors in wrong place (Schematic page 18).

Figure 38: OFFSET_1 & OFFSET_2 C5_3, C8_3, C5_4, C8_4, C5_5 & C8_5 decoupling on board.

Figure 39: OFFSET_1 & OFFSET_2 C5_1, C8_1, C5_2 & C8_2 decoupling on board.

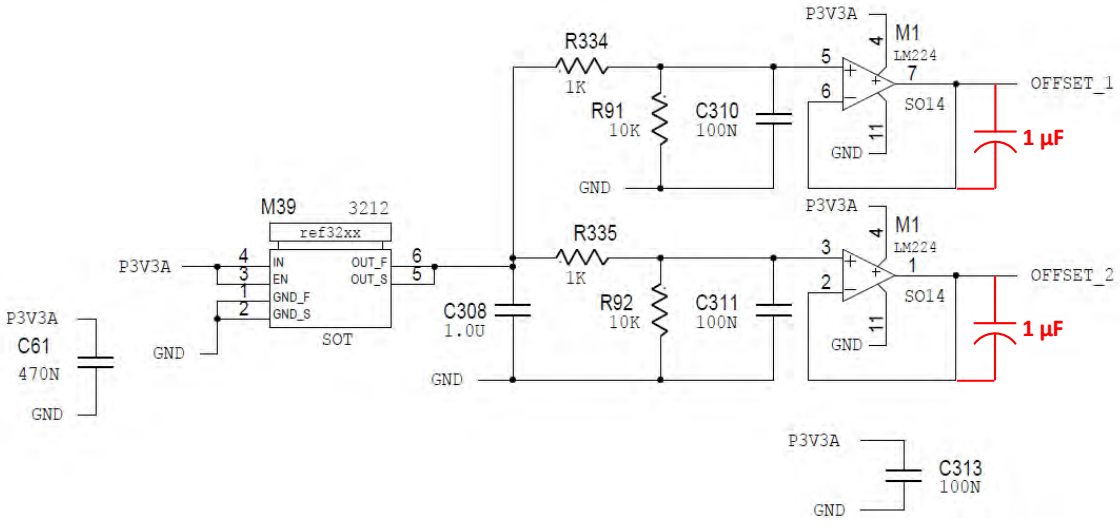
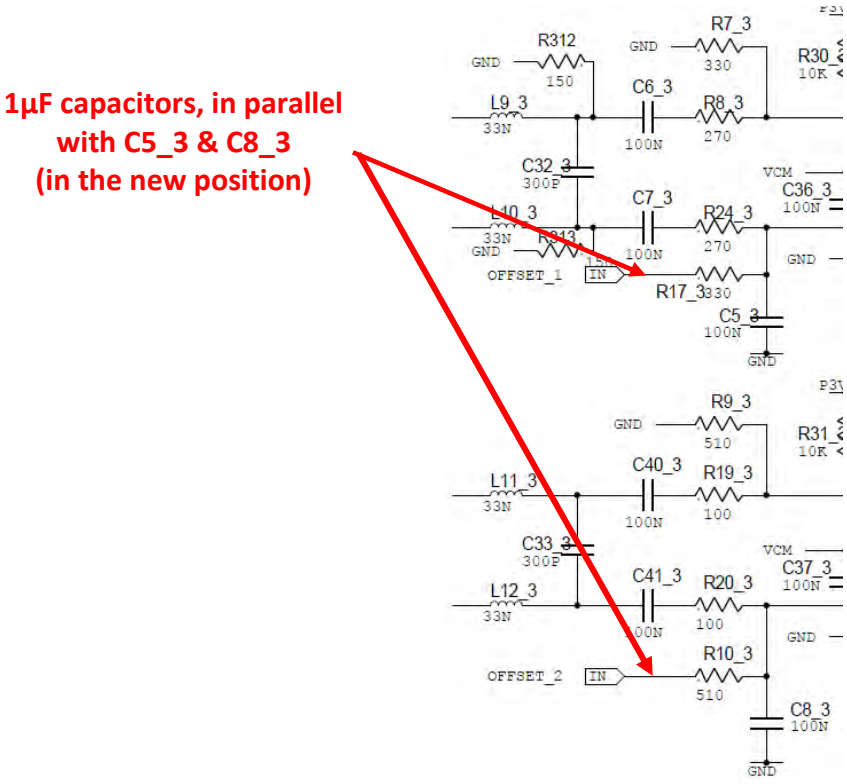
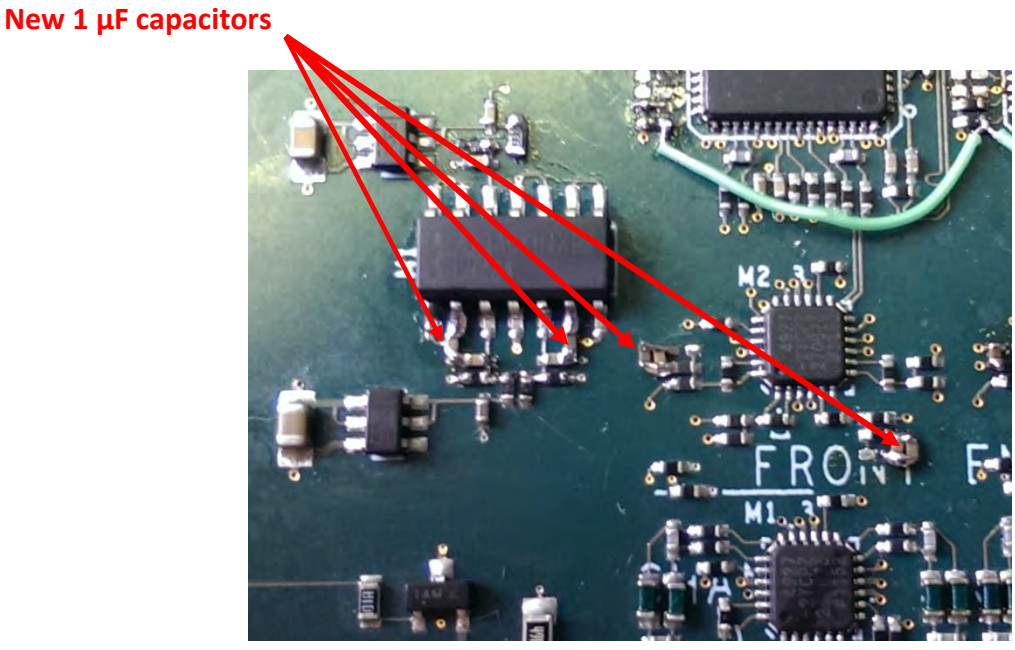
Figure 40: OFFSET_1 & OFFSET_2 amplifiers decoupling (Schematic page 15).

Figure 41: OFFSET_1 & OFFSET_2 decoupling close ADC (Schematic page 18).

Figure 42: OFFSET_1 & OFFSET_2 amplifier decoupling and close ADC on board.

4 Tantalum or ceramic decoupling capacitors must be soldered on board on each OFFSET signal. 2 on amplifier Offset outputs. The 2 others must be close the ADCs.

Be careful with the capacitor's polarity, it is a Tantalum technology.
Number of operation: 4

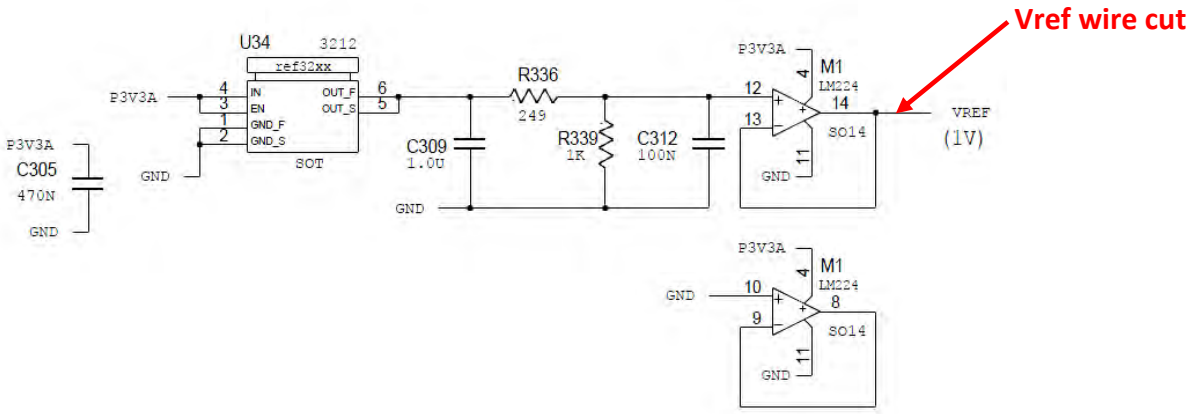
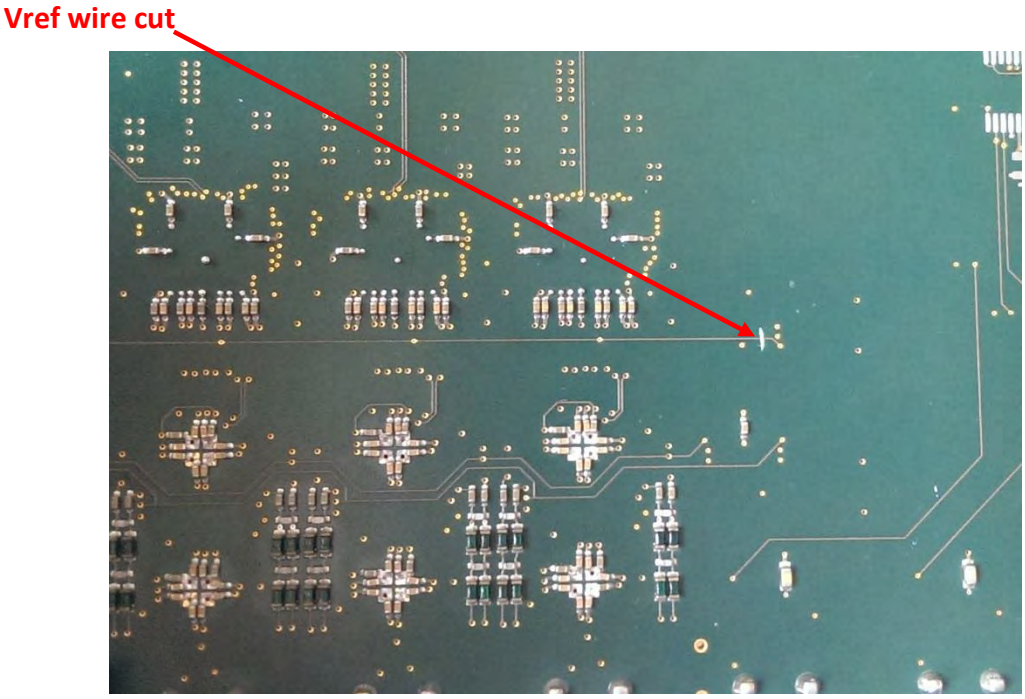
Figure 43: Disconnected Vref provided by M1 amplifier (Schematic page 15).

Figure 44: Vref Disconnected cut on board.

Vref wire provides 1 Volt to all ADCs. A wire cut must be made just after the M1 output pin.

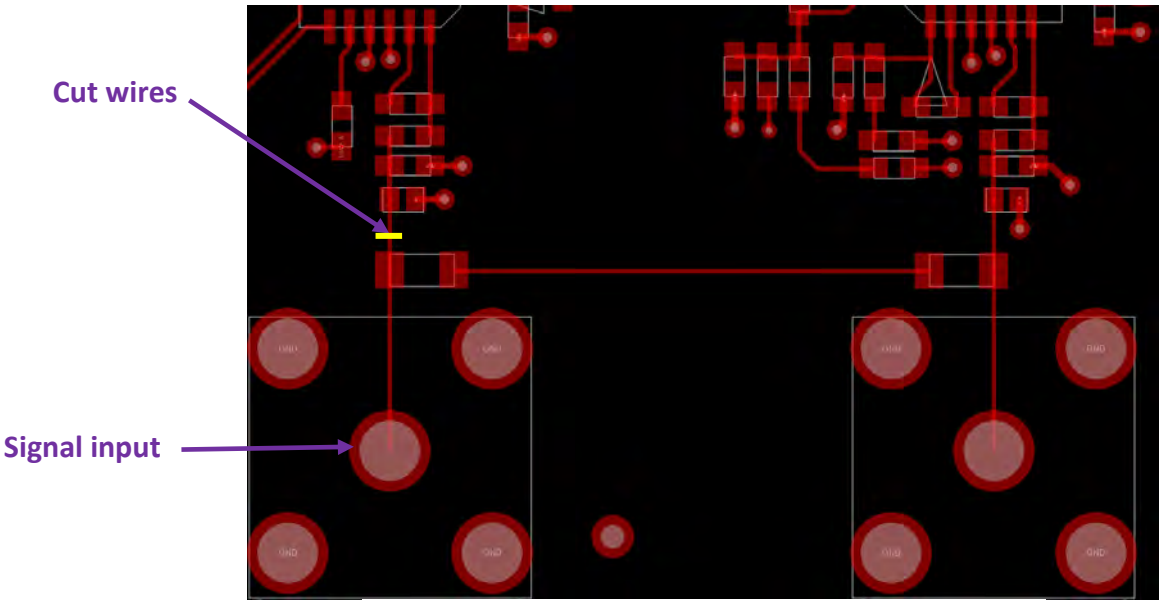
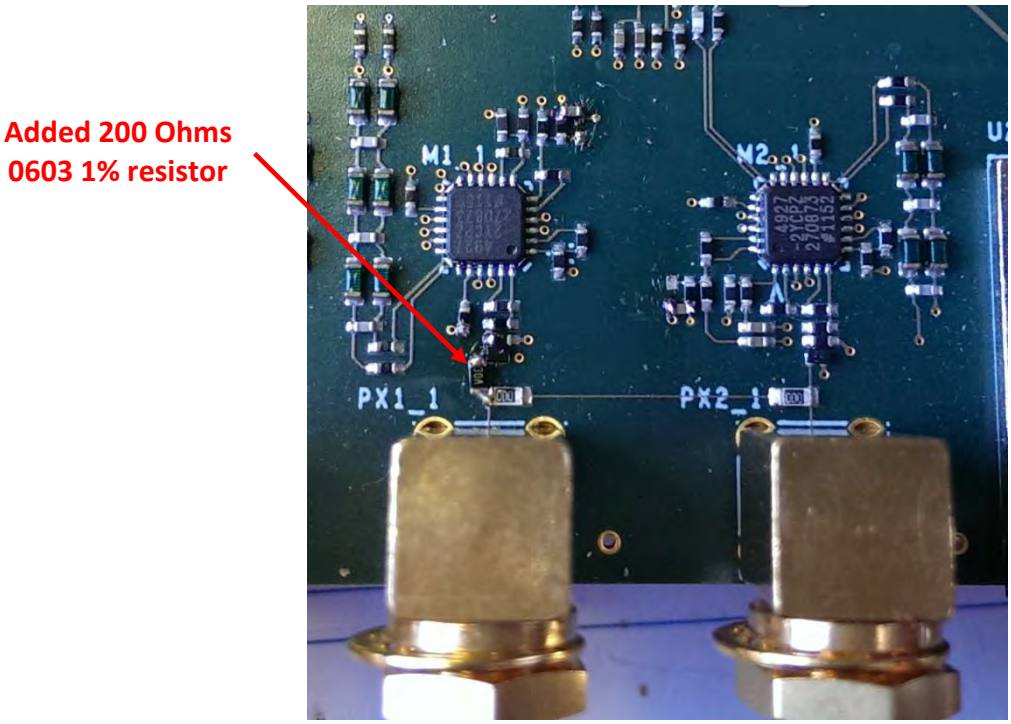
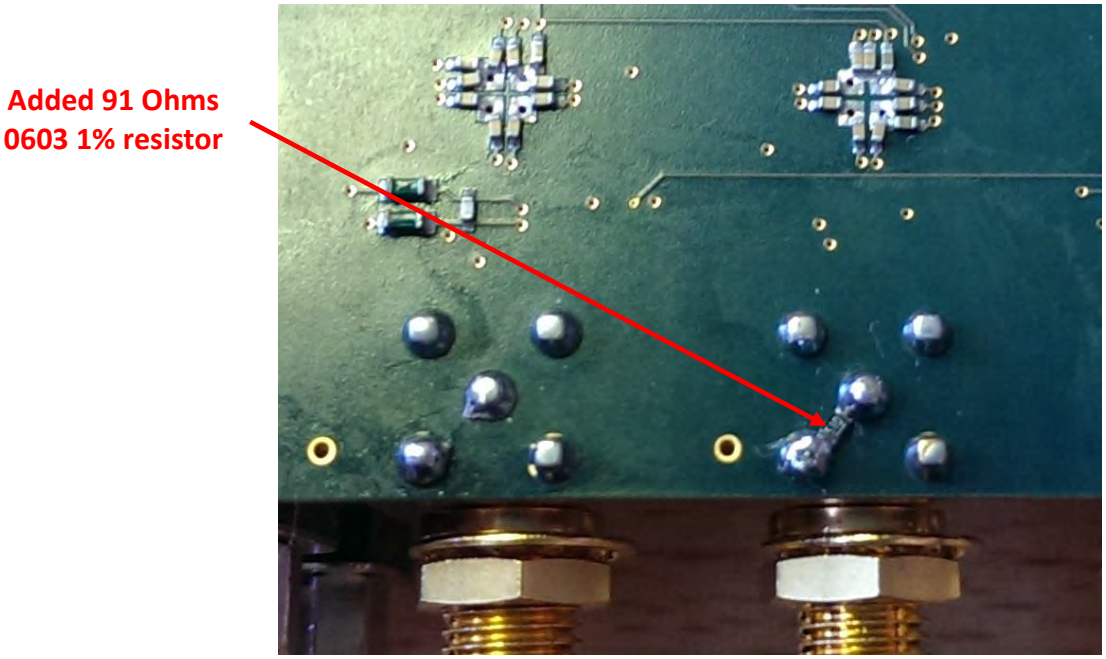
Figure 45: SSD analog input Wire Cut.

Figure 46: 200 Ohms resistor added.

Figure 47: 91 Ohms resistor added.

For SSD detector the type 3 front-end design must be implanted with a type1 Bill Of Material. For the impedance adaptation a wire must be cut and a resistor 200 Ohms and 51 Ohms 0603 package added.

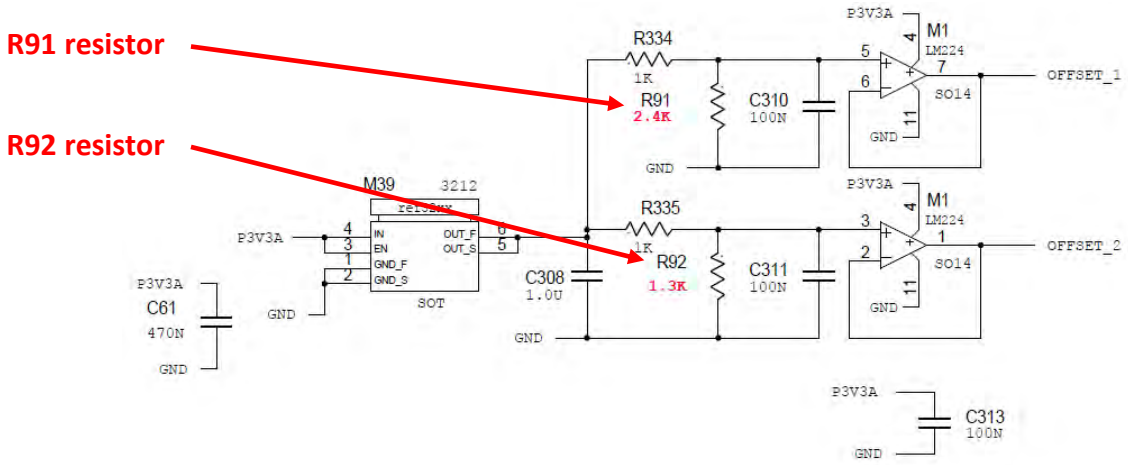
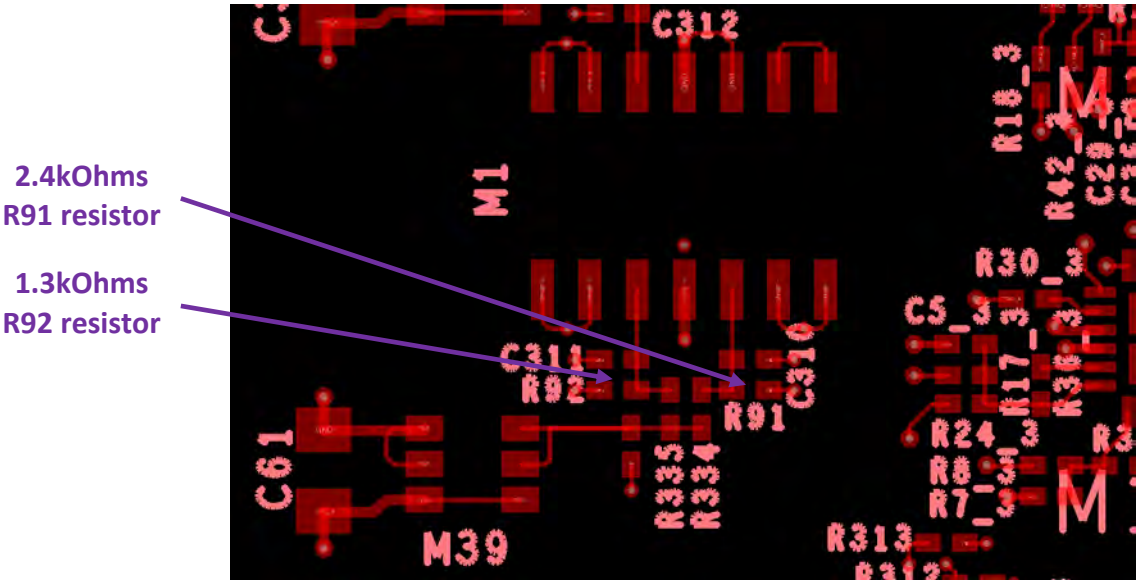
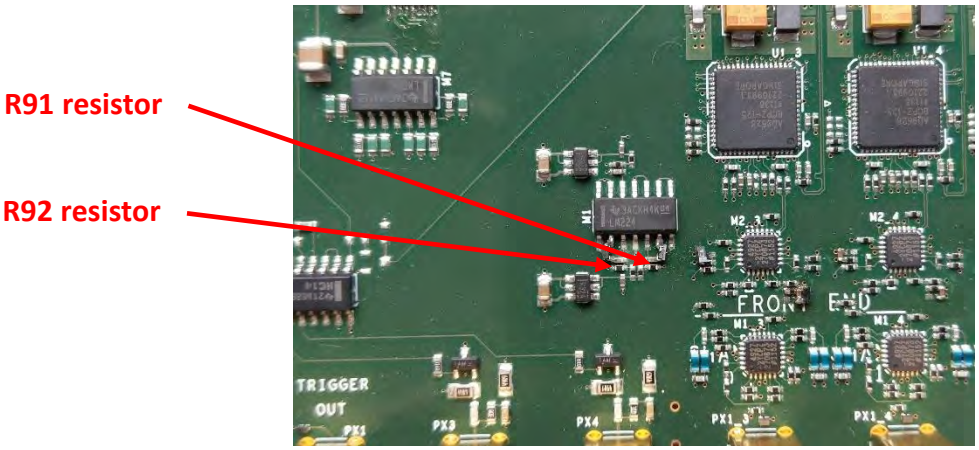
Figure 48: New resistor value for R91 an R92 (Schematic page 15).

Figure 49: New resistor value for R91 an R92.

Figure 50: New resistor value for R91 an R92.

The Reference Voltage value must be changed. R91 resistor value must be 2,4 kOhms and R92 1,3 kOhms in 0402 1% (NCRs n° 2.-47 & 2-48)

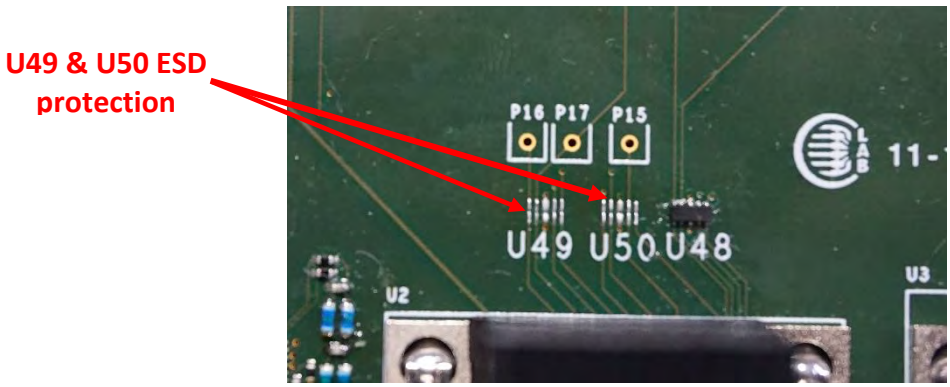
The RCLAMP0524J.TCT ESD component modifies the "Radio RS232" signal. The U48 & U50 must be removed. The MAX3218 RS232 interface has already 15kVolts ESD protection.

Figure 51: Removed U49 & U50 ESD RCLAMP components.
