Pierre Auger Observatory

Surface Detector Electronics Upgrade

UUB Pre Prototype Production Report

UUB Model version: SDE-002-002-IE00

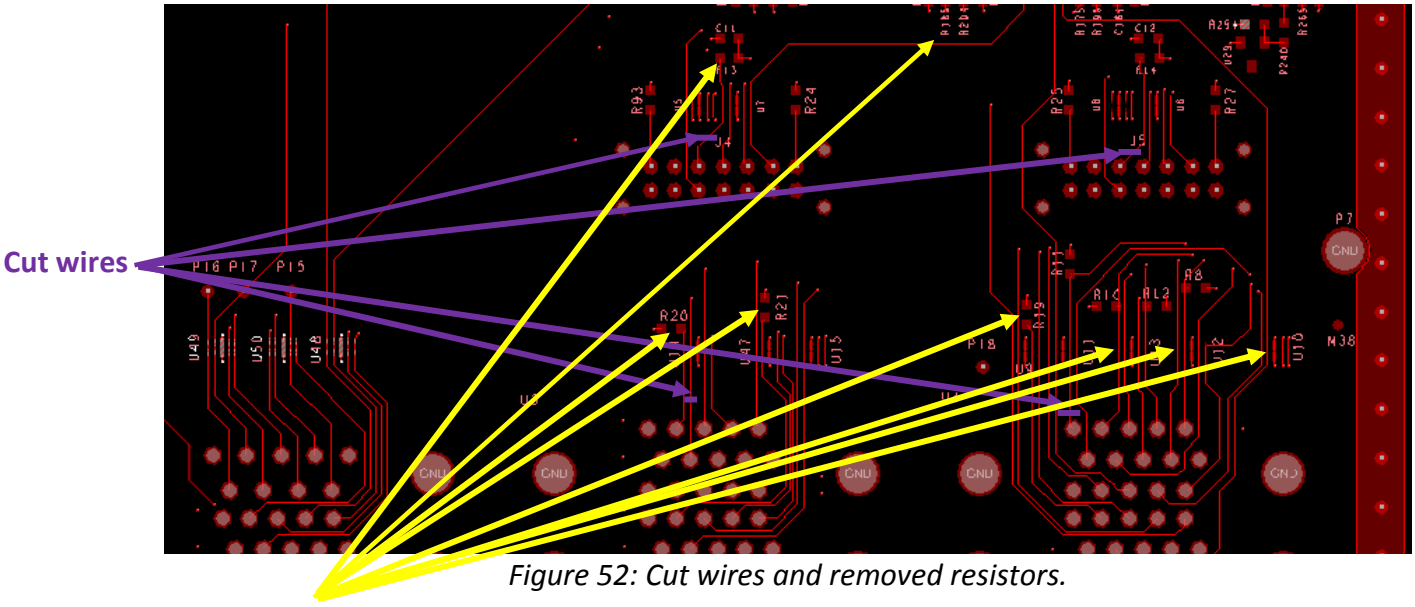
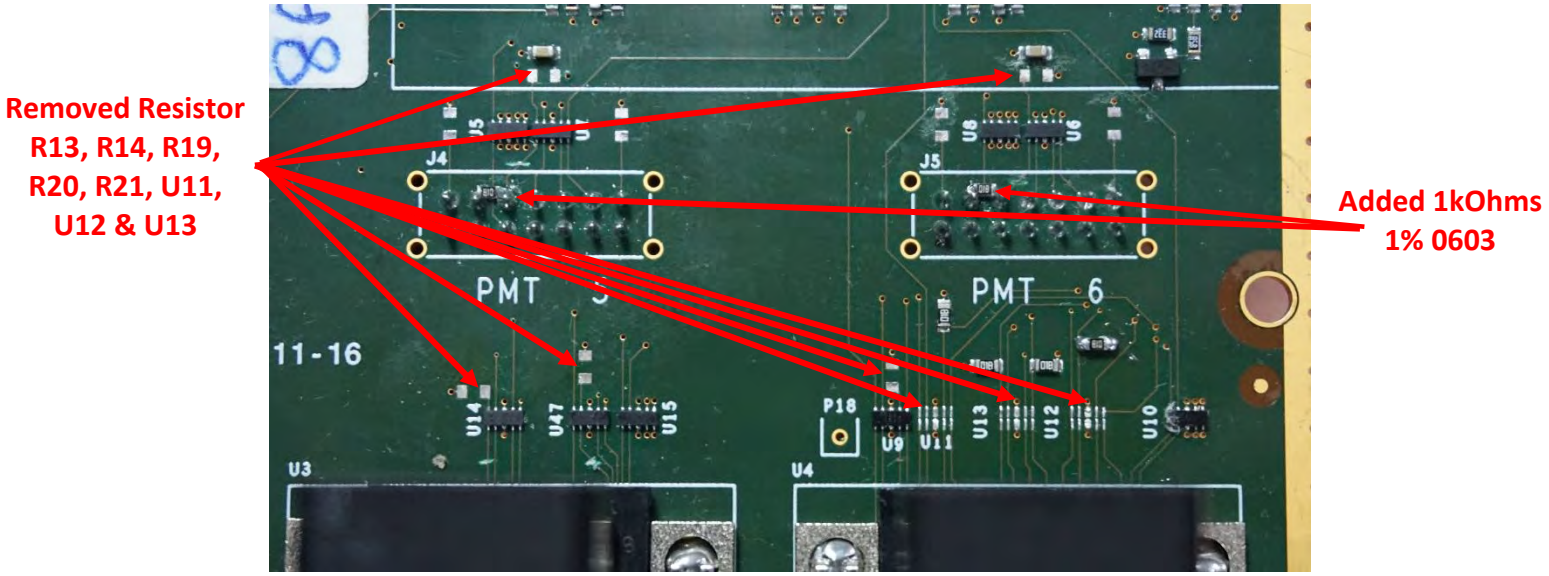
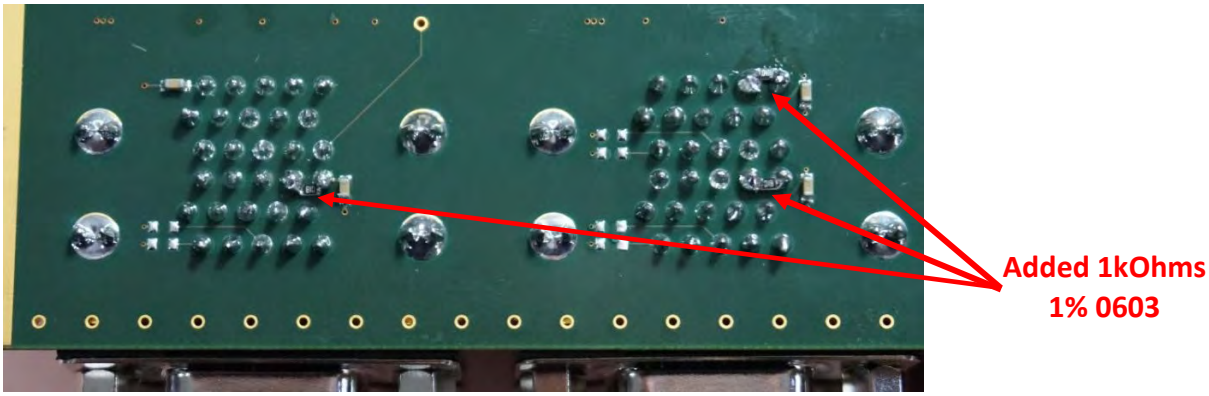
The RCLAMP0524J.TCT ESD component modifies signals for PMT and Tank devices. Wires must be cut, R13, R14, R19, R20 & R21 resistors and U11, U12 & U13 must be removed.

Figure 52: Cut wires and removed resistors.

Removed 1kOhms Resistor R13, R14, R19, R20, R21, U11, U12 & U13

Figure 53: Cut wires, resistors & ESD removed and R7_X & R8_X added resistors on top side.

Figure 54: resistors added on bottom side.

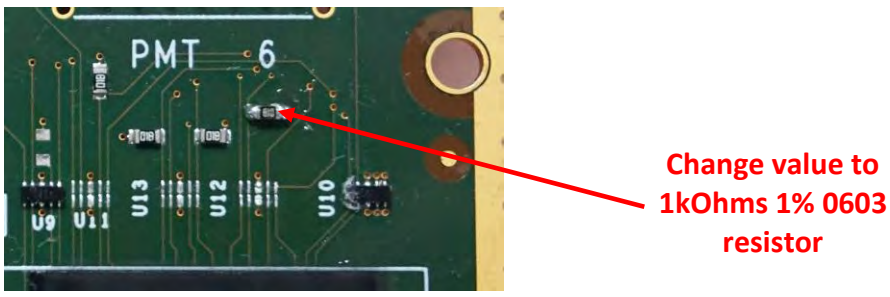
Figure 55: resistors changed on top side.

The Temperature sensor power supply adjustment R8 resistor must be changed. The value was 22 kOhms 1% 0603 and it must be 1 kOhms 1% 0603.

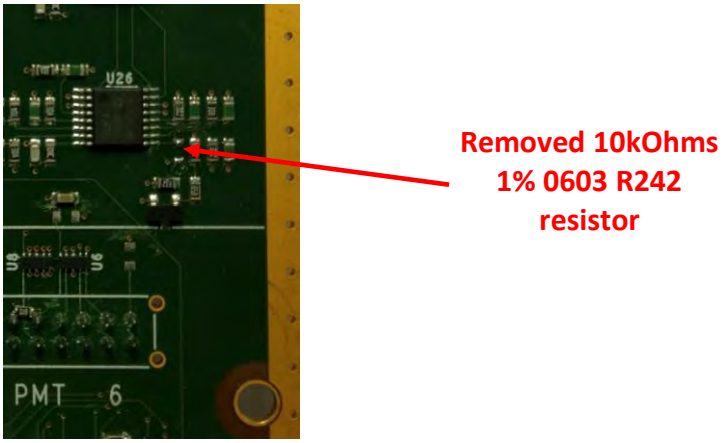
The -3,3 Volts monitoring schema is not conform (NCR n° 2-52). For the Engineering Array the 10 kOhms R242 resistor must be removed.

Figure 56: resistors changed on top side.

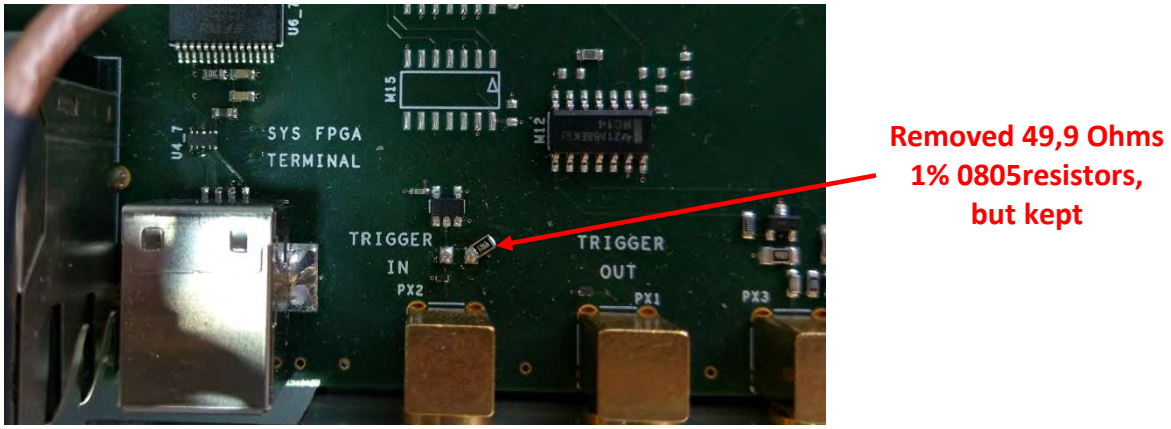
The input 50 Ohms R29 resistor must be removed, but kept on board. There is too many attenuation on the signal.

Figure 57: R29 resistors removed on top side.

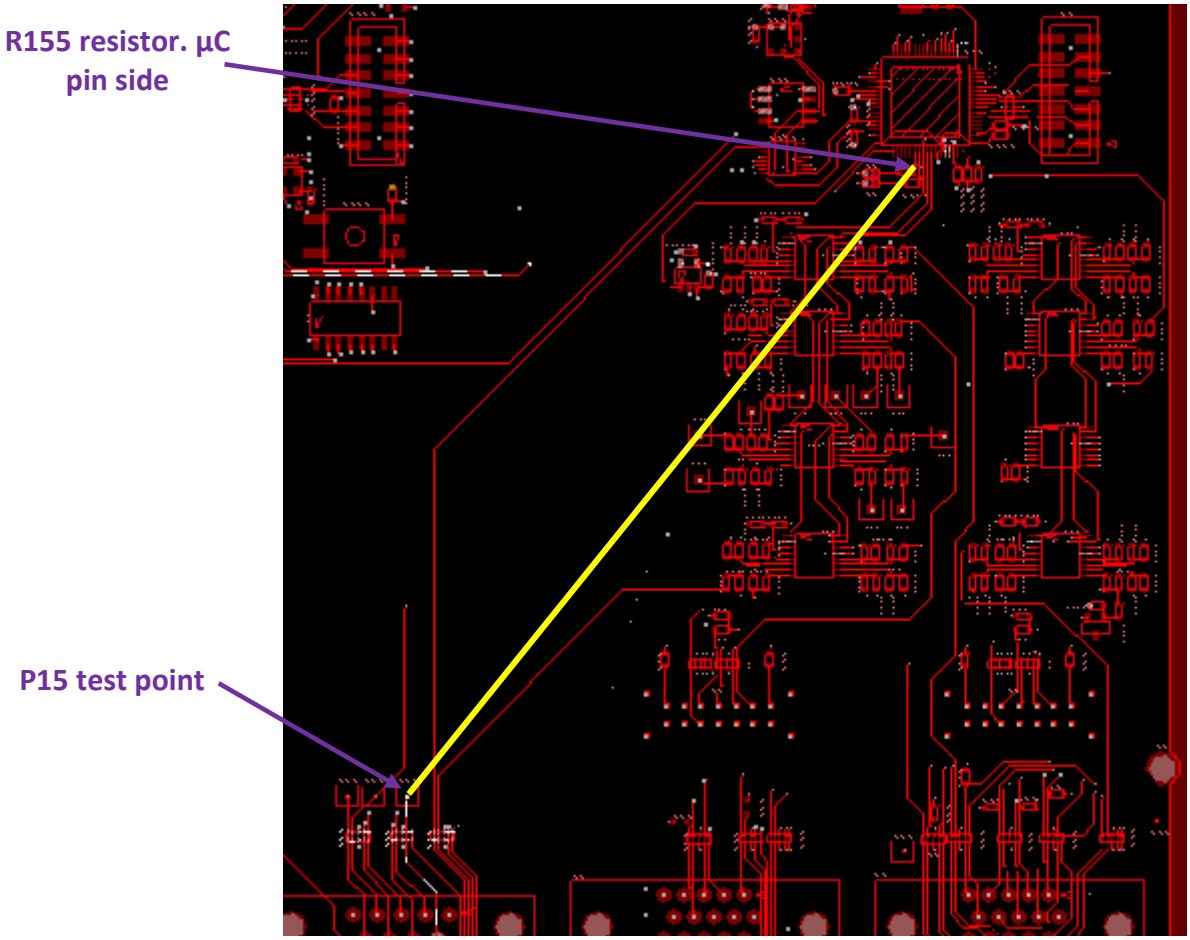
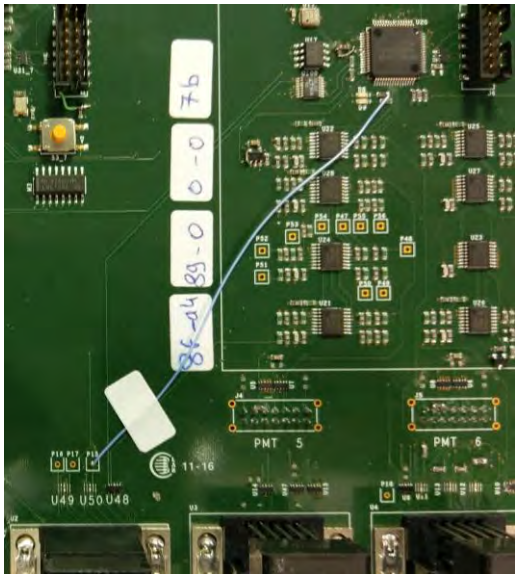
The "RADIO Reset" was managed by FPGA, but now it must be managed by the Slow-Control. It's already managed the UUB's Reset.

Figure 58: "RADIO Reset" Wire connection between P15 test point and R155resistor.

Figure 59: "RADIO Reset" Wire on top side.
